**ADDENDUM TO THE EXPANDED SITE INVESTIGATION OF THE LAKE
CALUMET CLUSTER SITE**

**LAKE CALUMET CLUSTER SITE
ILD 000 716 852
CHICAGO, ILLINOIS**

**PREPARED BY:
ILLINOIS ENVIRONMENTAL PROTECTION AGENCY
BUREAU OF LAND
OFFICE OF SITE EVALUATION**

February 8, 2005

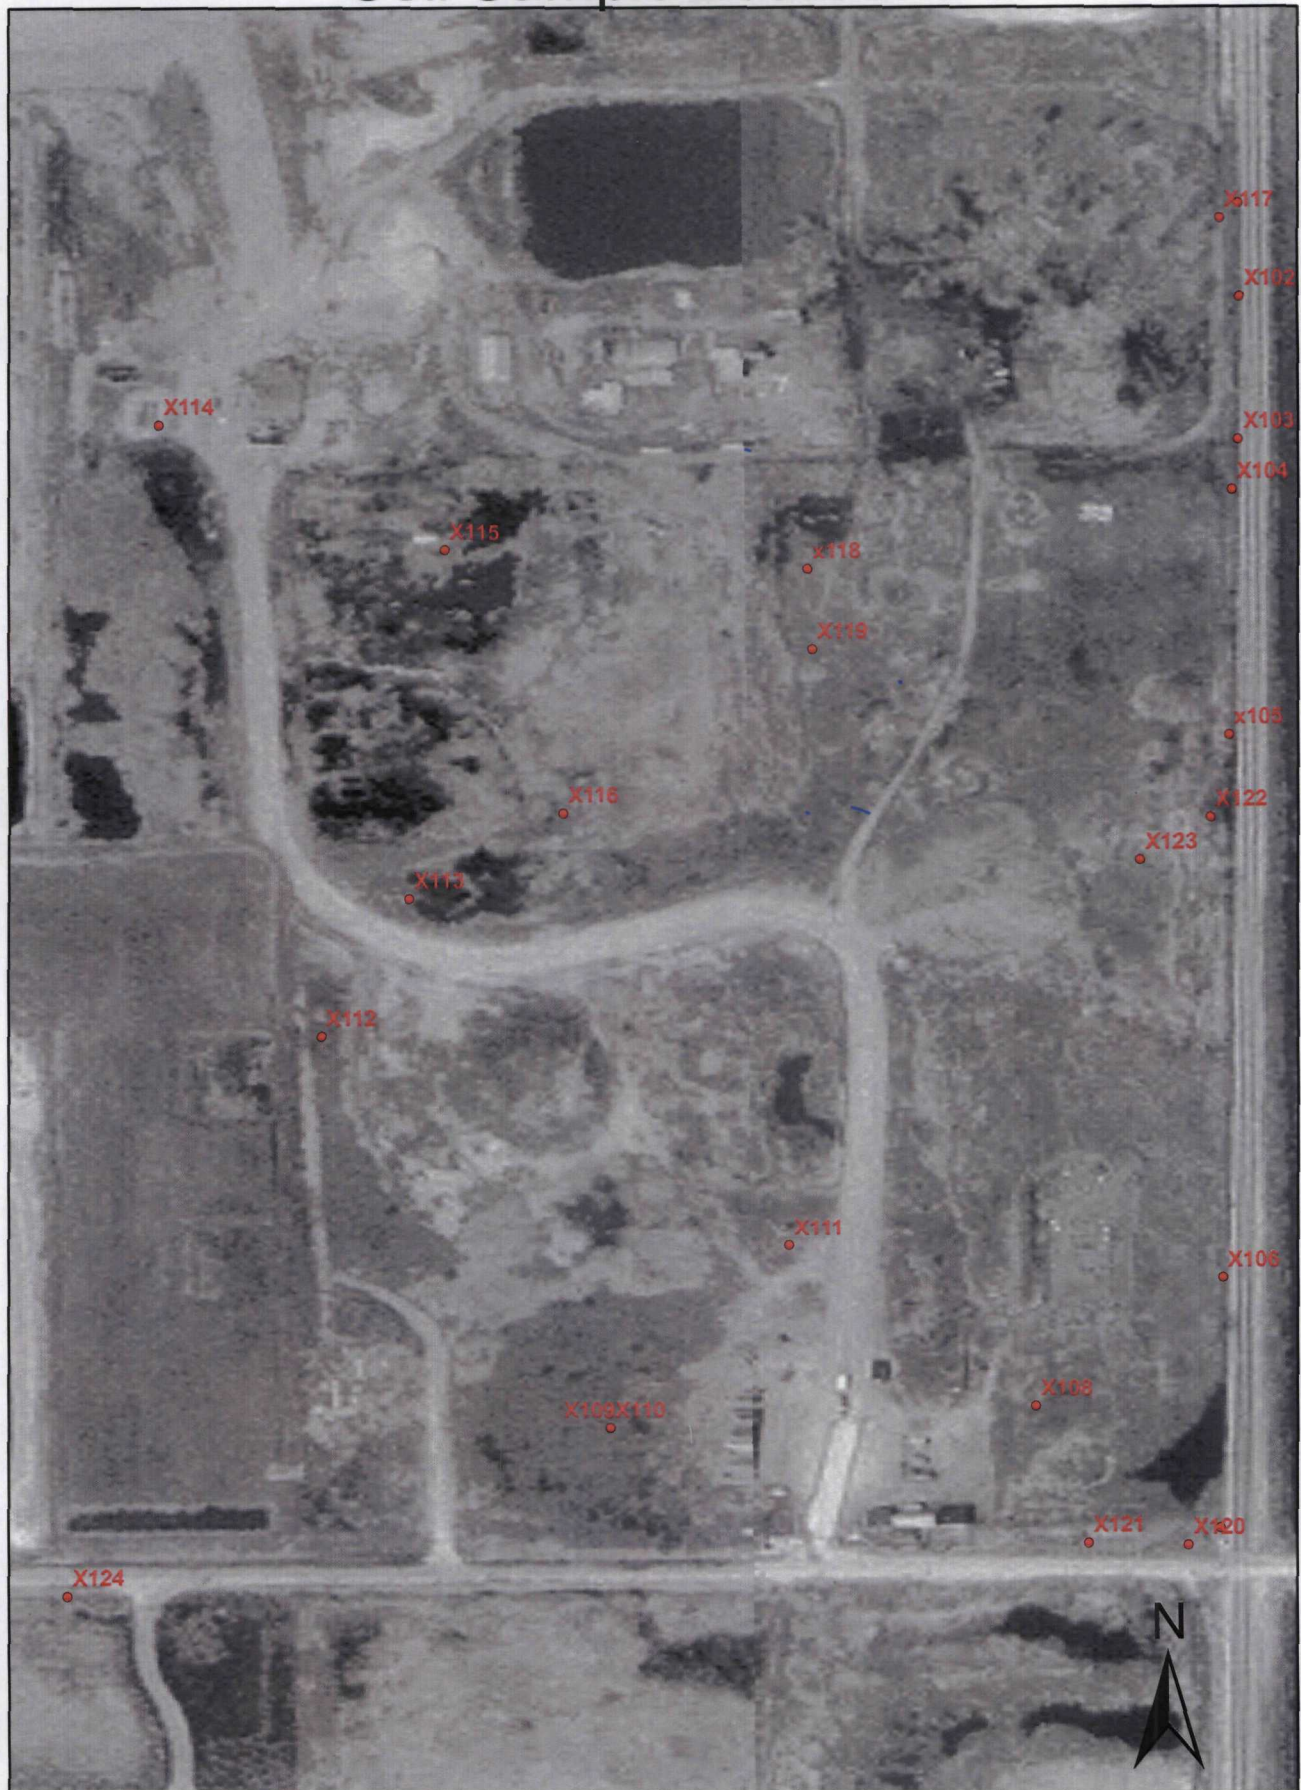
Figure 2
Soil Sample Locations

Soil samples X108 through X119 were collected from the Cluster Site on November 30, 2004. Information concerning these samples can be found in Table 1 Sample Descriptions.

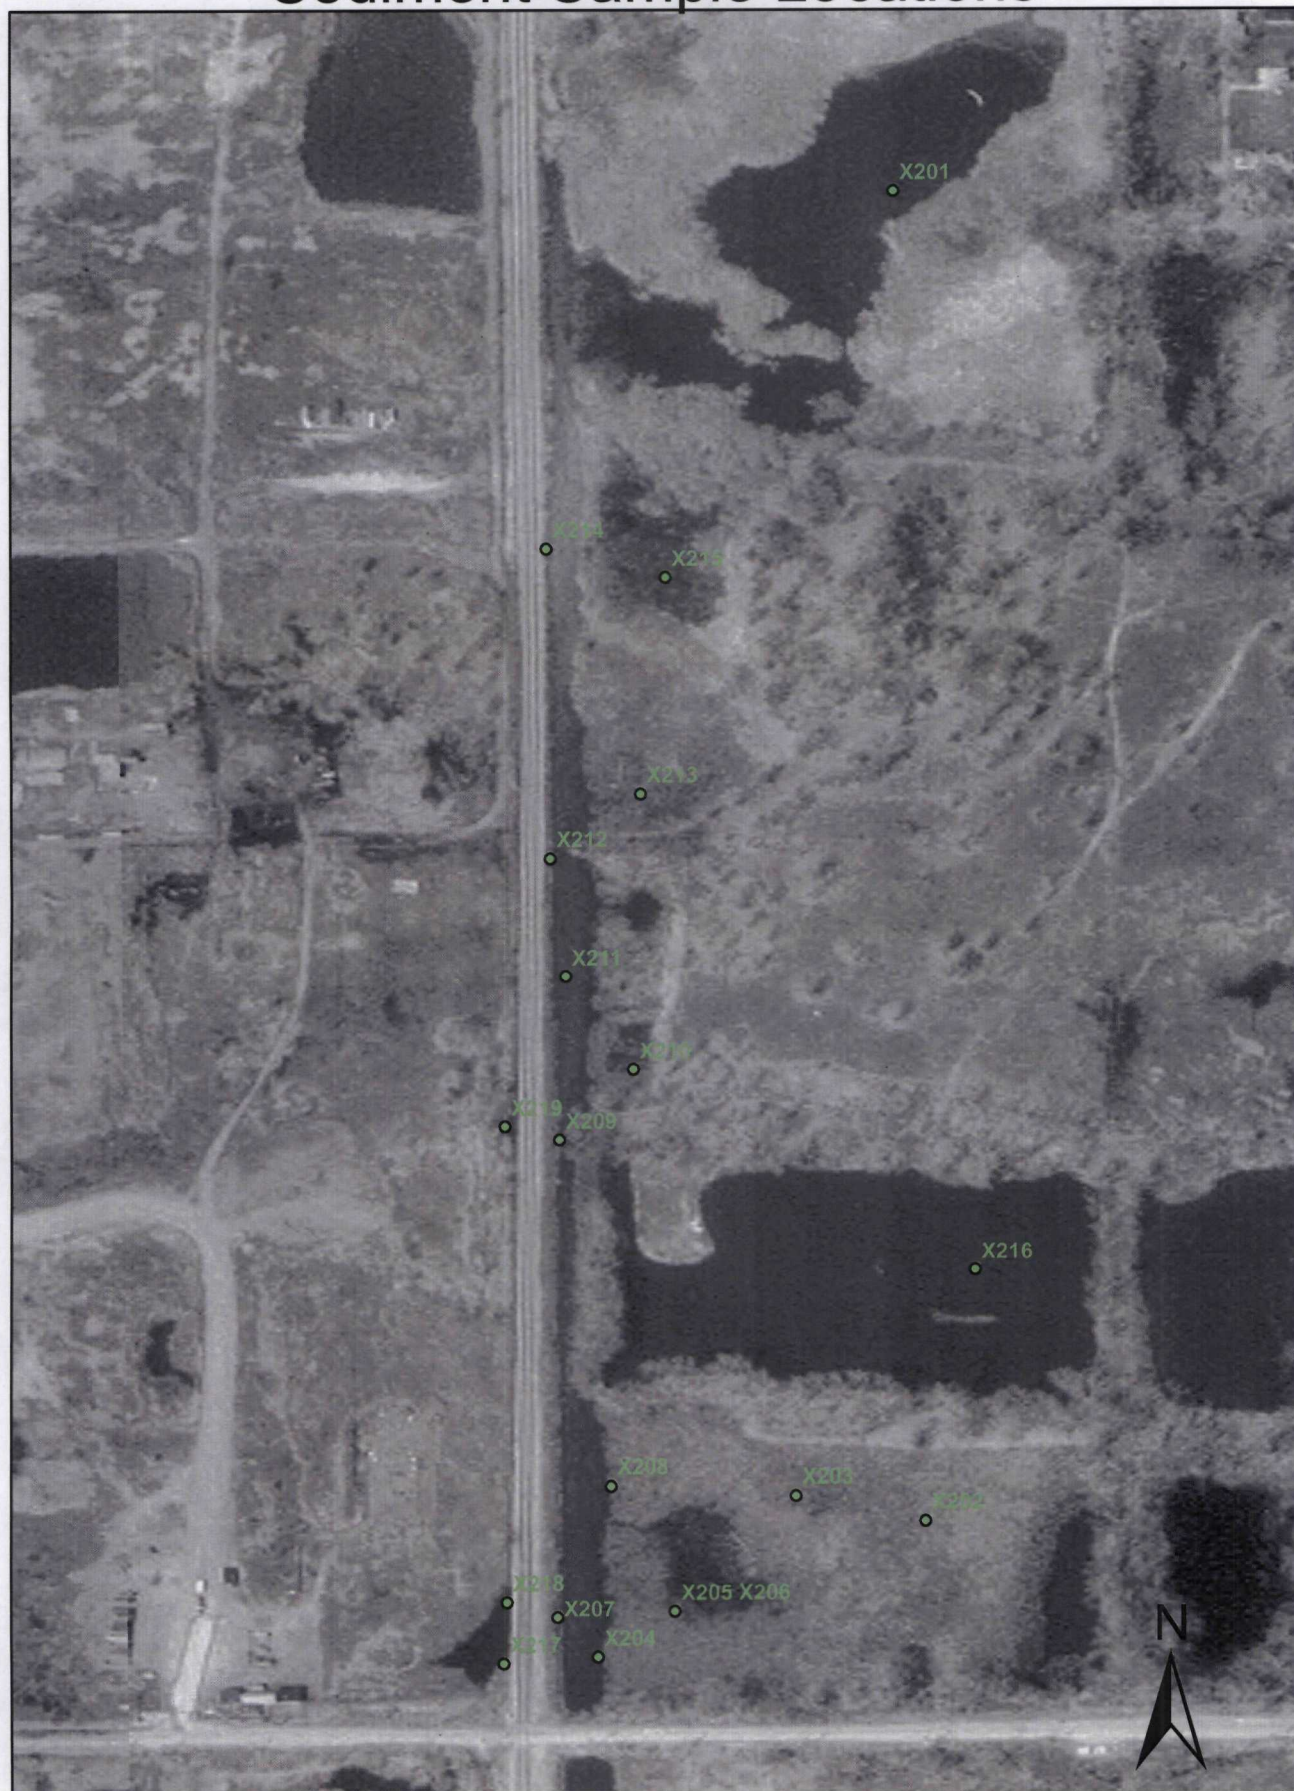
Figure 3
Sediment Sample Locations

On December 2, 2004, sediment sampling continued. X215, X201 and X216 were collected from IRM. S110, X217 and X218 were water and sediment samples collected from the small ponded area in the southeast corner of the Cluster Site. S110 was collected before X217 and downstream from X218. Soil samples X120 and X121 were collected from the ditch paralleling 122nd Street and the southern border of the Cluster Site. S111 and X219 were collected from an area of standing water near the eastern portion of the site. Surface water sample S111 was collected prior to X219, the sediment sample. X122 through X124 were collected from different areas on and around the Cluster Site. Additional information about the sample collection depths and consistency

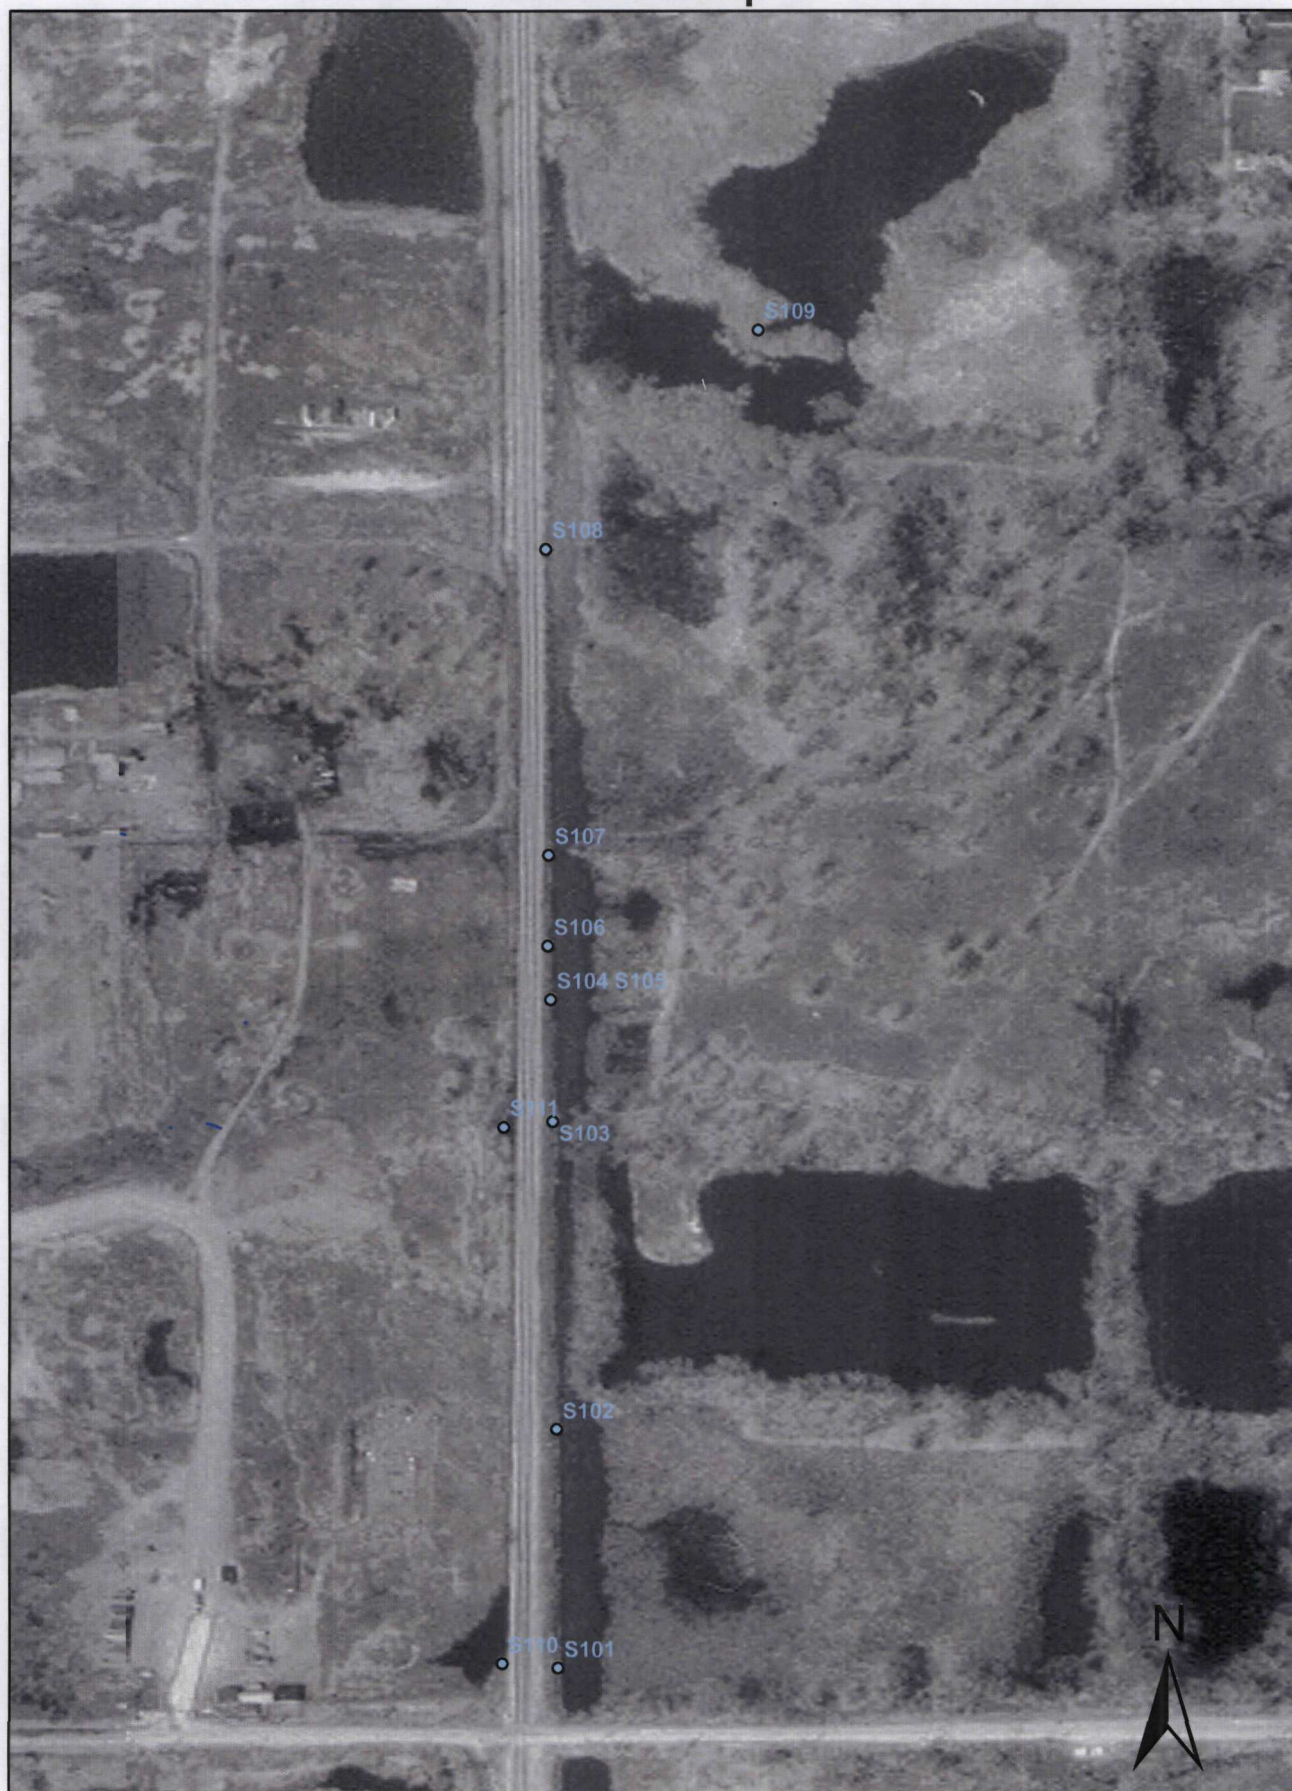
Figure 4
Surface Water Sample Locations

On December 1, 2004, sampling began in Indian Ridge Marsh (IRM). Surface water samples S101 through S108 were collected from the marsh from downstream to upstream, which is from south to north. After the surface waters were collected, sediment sampling began. Sediment samples X202 through X214 were collected on December 1 from south to north from downstream to upstream.

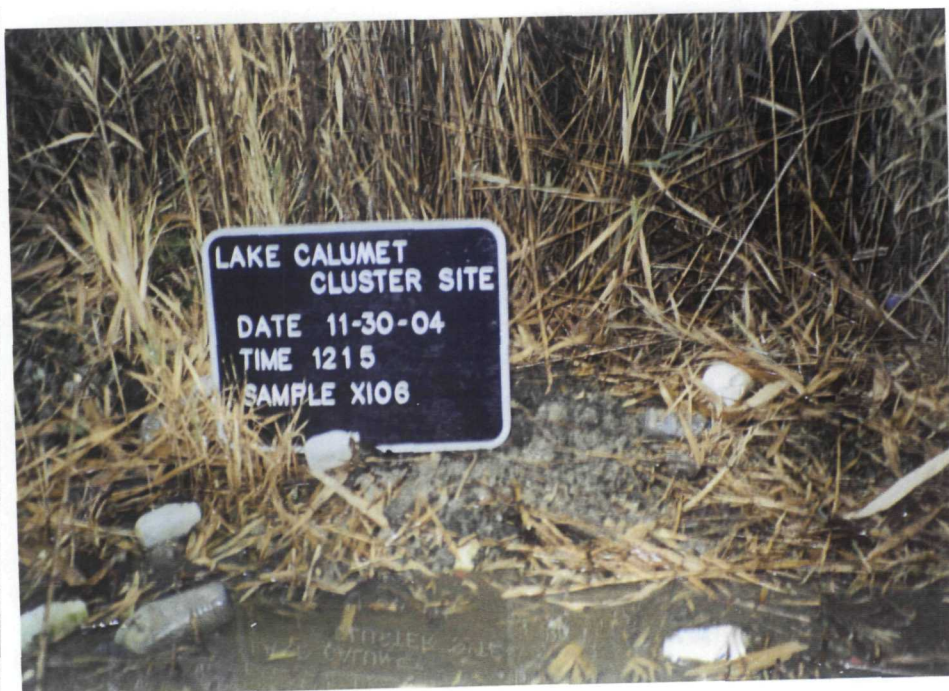
COMMENTS: Photo taken of sample X106. Sample collected from the embankment from a depth of 2 to 6 inches. Sample consisted of a gravelly clay silt which was below a 2 inch gravelly layer. Collected just above the water line in the ditch.

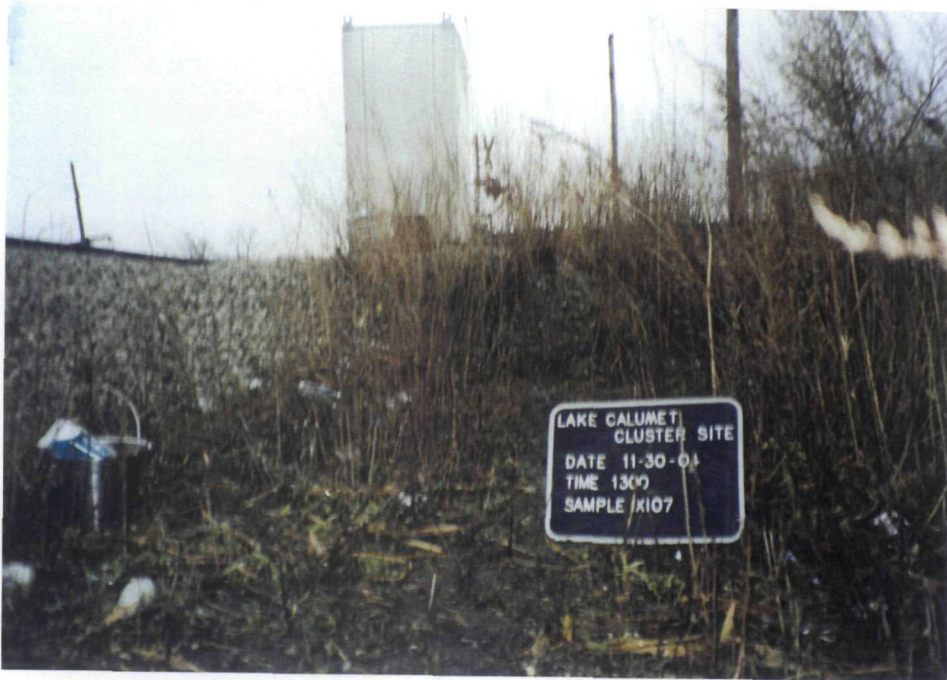
COMMENTS: Photo taken of sample X107. This sample was designated the MS/MSD. Sample was collected from a depth of 4 to 6 inches. Sample location was near the intersection of RR and 122nd Street. Sample consisted of a sandy loam with very little gravel. Just south is the ponded area located at the southeastern portion of the Cluster Site.

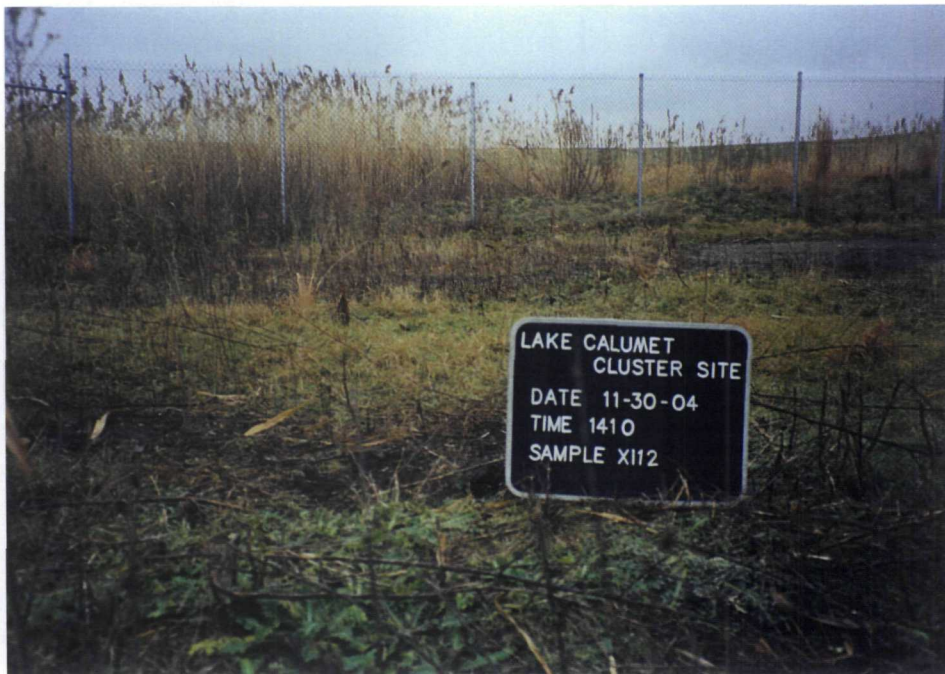
COMMENTS: Photo taken of sample X112. Sample was located near the northwest corner of the unnamed parcel near the fence surrounding Paxton Avenue Lagoons. Sample was collected from a depth of 2 to 4 inches from a silty brown loam with some slaggy material present.

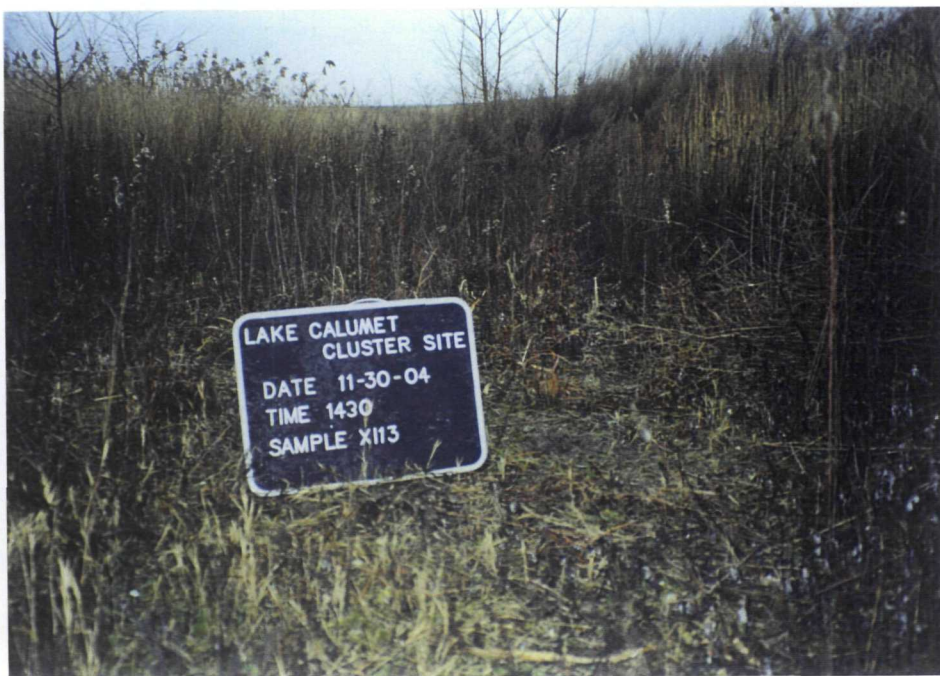
COMMENTS: Photo taken of X113. This sample was located in the area between the road and the portion known as Alburn. Sample was collected from a gray brown silty material with small rocks from a depth of 2 to 4 inches.

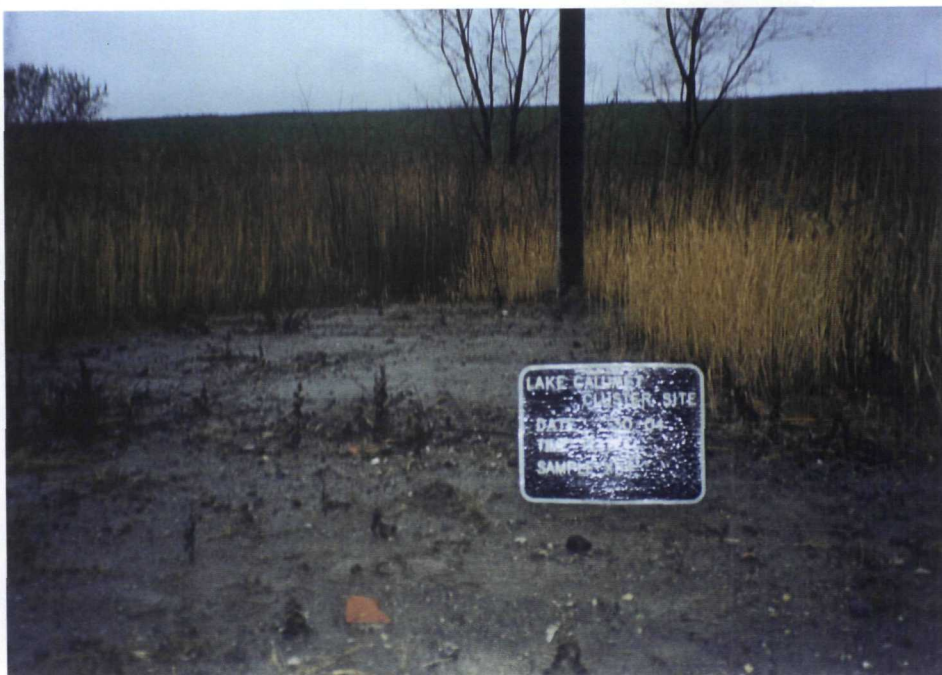
COMMENTS: Photo taken of sample X114. Sample location was the extreme northwest corner of the Cluster Site. Sample was collected from a depth of 2 to 4 inches and consisted of a silty brown loam with gravel. Sample was collected from an area that had been graded sometime in the past, not recent. Wet photoboard makes it difficult to read.

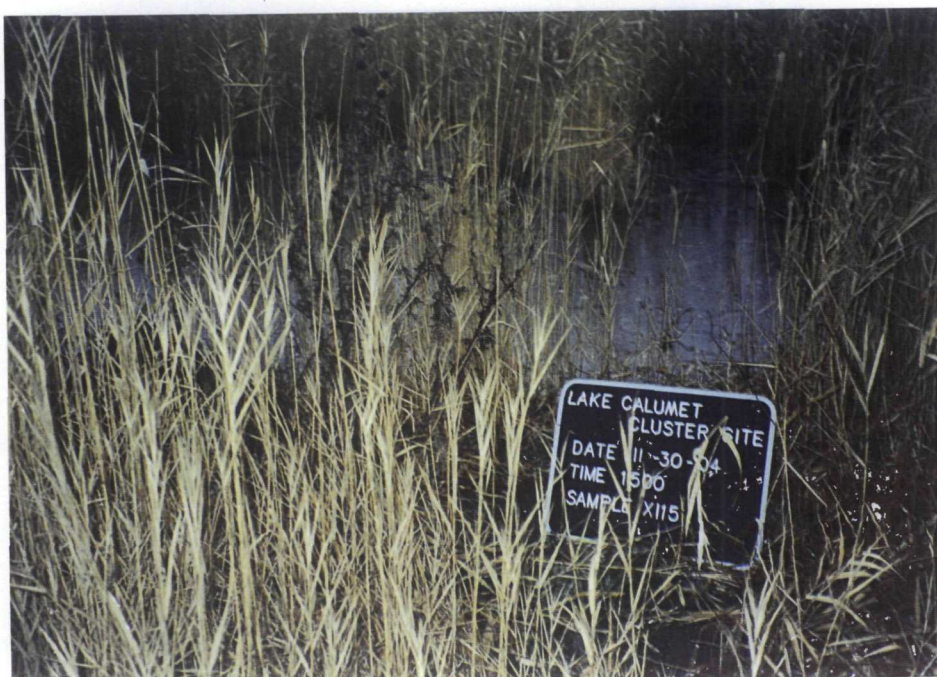
COMMENTS: Photo taken of sample X115. Sample location was from the Alburn portion. Sample was collected from a depth of 2 to 4 inches and consisted of a silty gravel and magenta/pink paint chips were present.

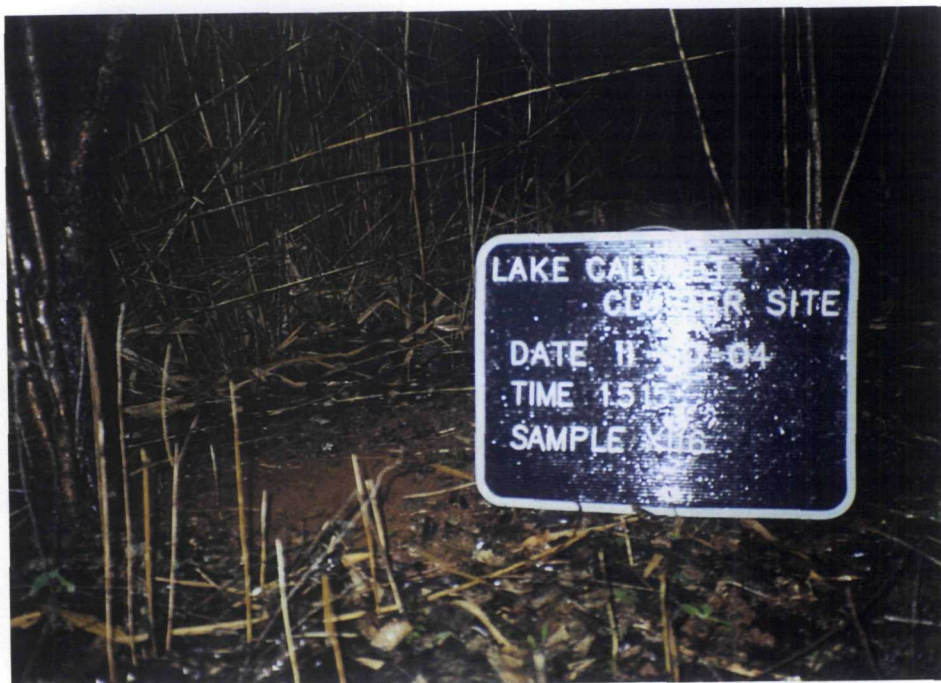
COMMENTS: Photo taken of sample X116. Sample location was south of the Alburn portion in a small stand of trees. Sample was collected from a depth of 2 to 4 inches and consisted of a reddish airy material. Caught a glimpse of wild dogs in this area.

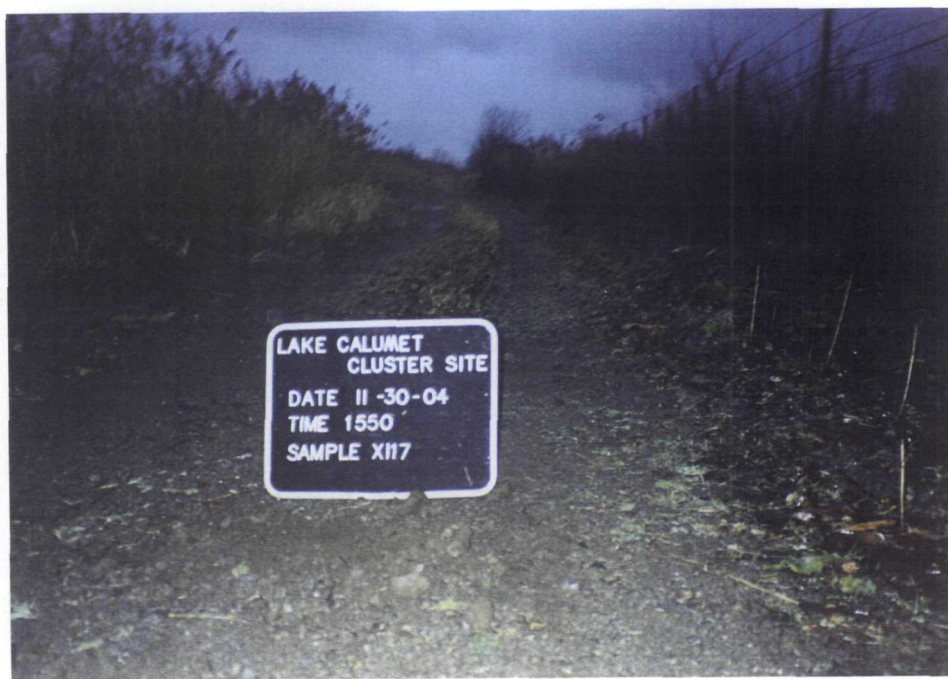
COMMENTS: Photo taken of sample X117. Sample location was in the northern portion of the site on the east side. Sample was collected from a depth of 2 to 4 inches and consisted of a slag material along with some fill material.

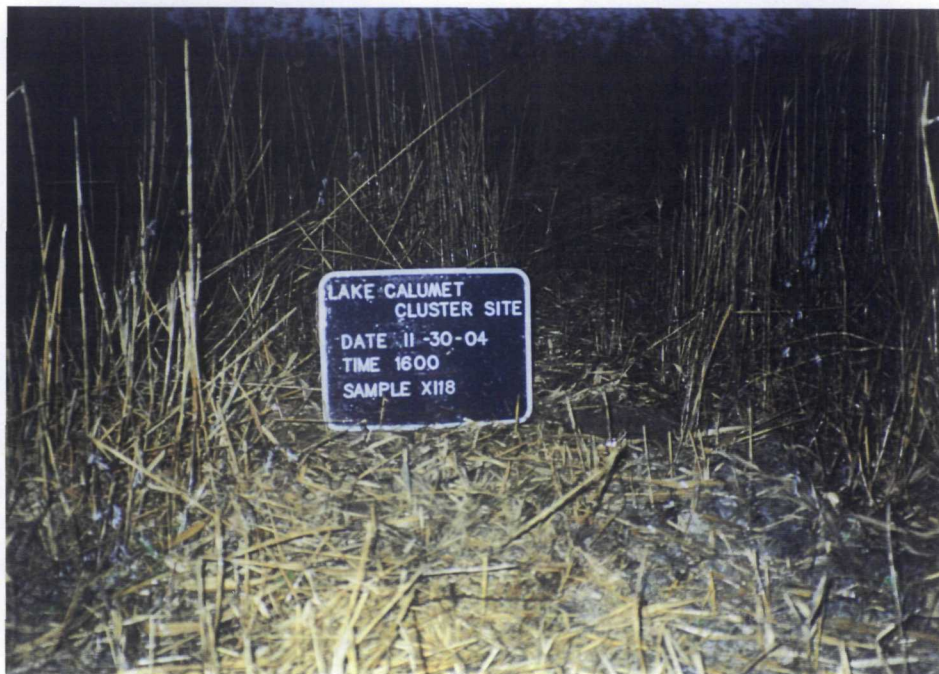
COMMENTS: Photo taken of sample X118. Sample was located to the east of the Alburn portion. Sample consisted of a brown slaggy loam with sand and was collected from a depth of 2 to 4 inches.

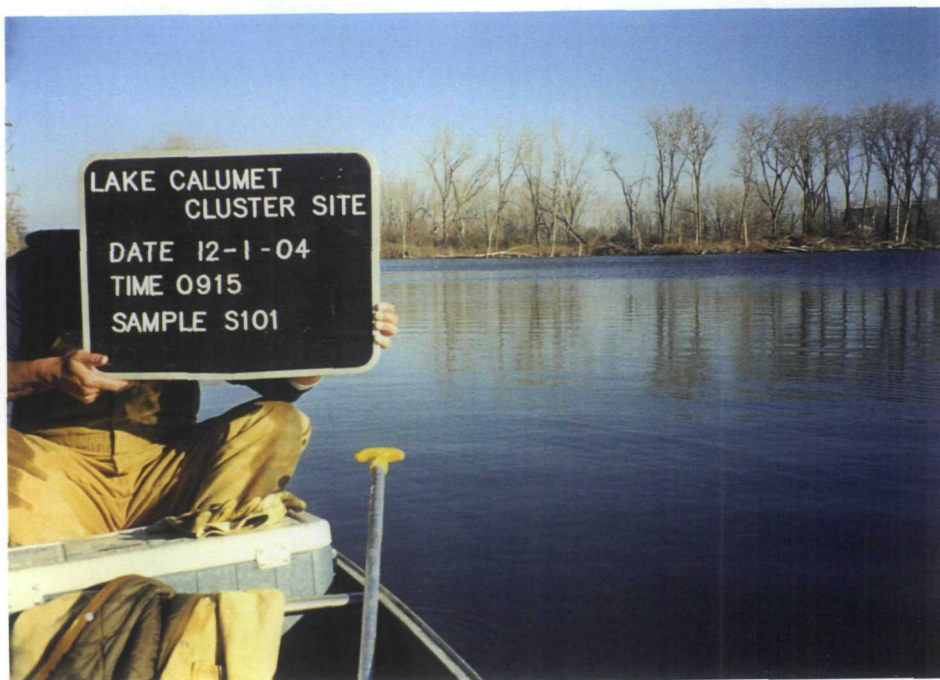
COMMENTS: Photo taken of S101. Sample was collected from the southern portion of Indian Ridge Marsh (IRM). Sample was collected from a depth of 12 inches. Water depth was approximately 1.5 ft. Sample was pretty clear.

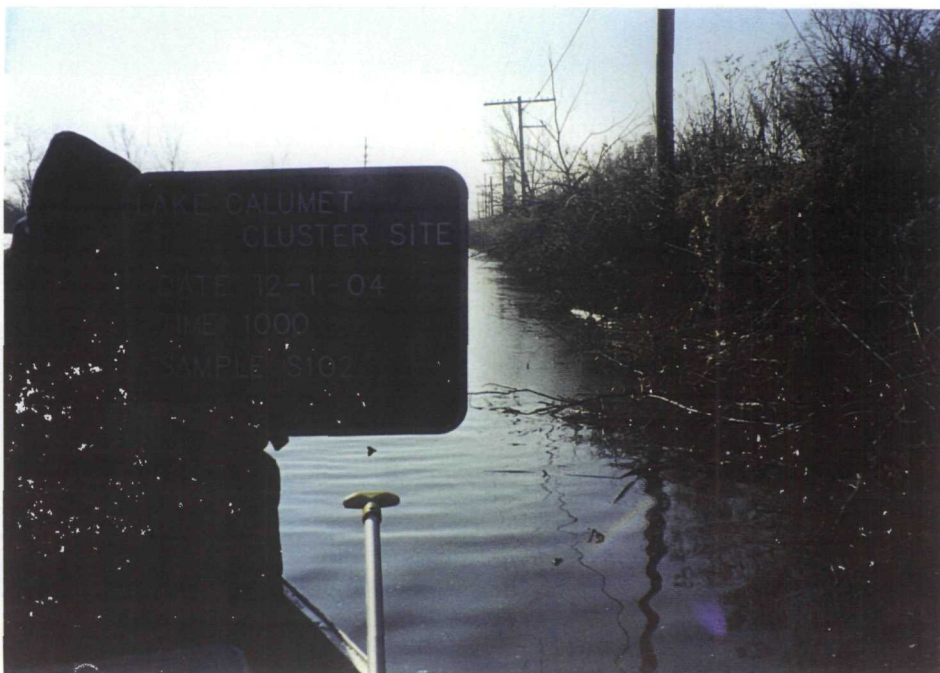
COMMENTS: Photo taken of sample S102. Sample was collected from the mouth area opening into the southern lagoon area. Sample was collected from a depth of 1 ft. Water depth from this location was approximately 1.5 ft.

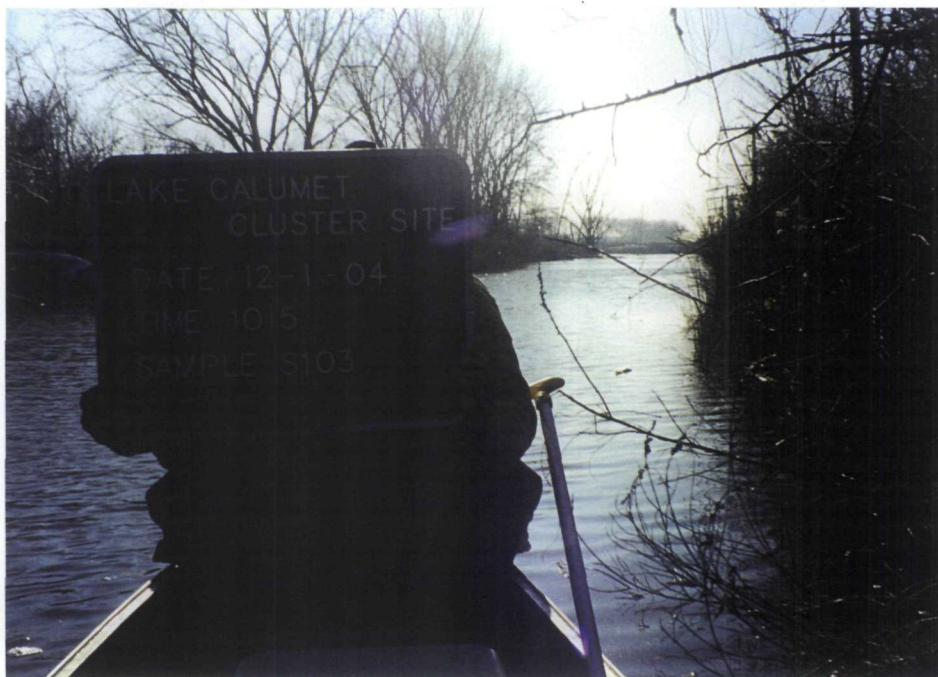
COMMENTS: Photo taken of samples S103. This sample location was near the north end of the first straight away. Sample was collected from a depth of 10 inches. Water depth at this location was approximately 12 inches deep. Sample was pretty clear.

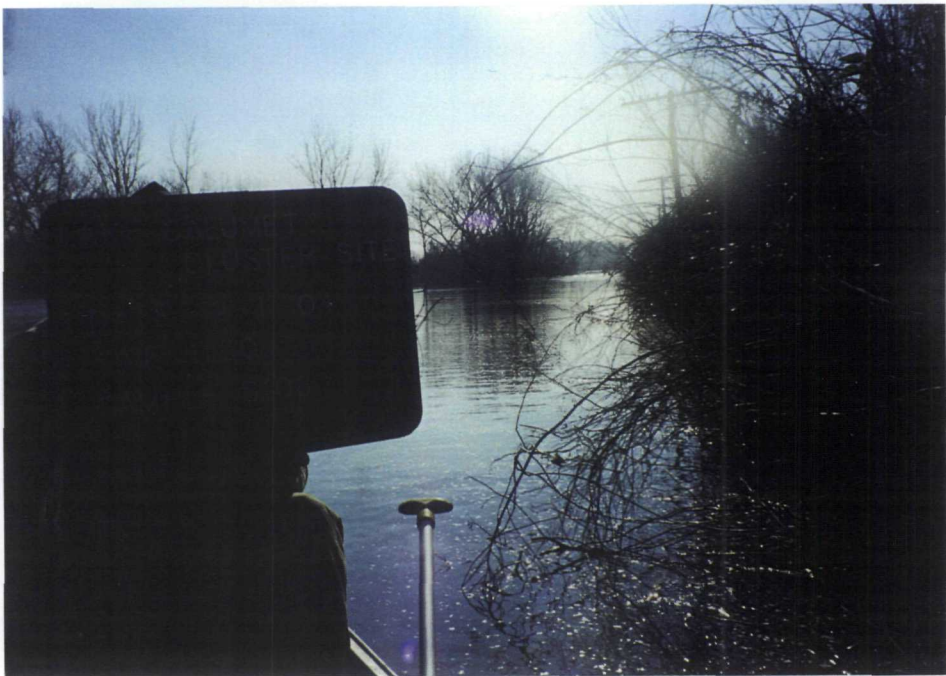
DATE: December 1, 2004
TIME: 1130
PHOTO BY: L. Range
PHOTO NUMBER: 5
ROLL NUMBER: 3
DIRECTION: South
COMMENTS: Photo taken of S106. Sample was located directly east from suspected areas of contamination on the US Drum parcel. S106 was collected from a depth of 1 ft from clear water. The water depth at this location was 1.5 ft.

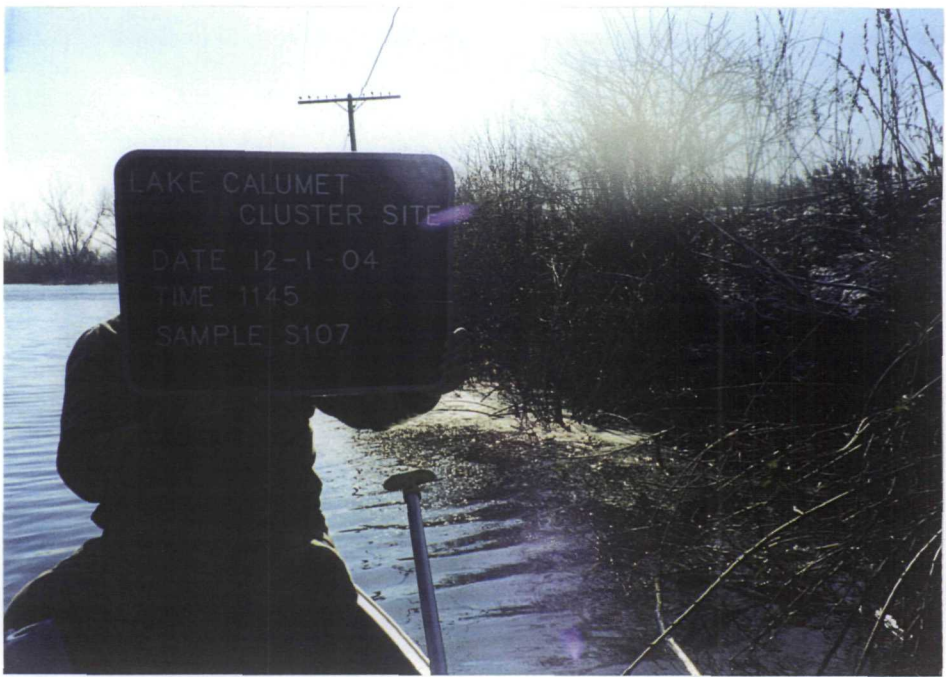
DATE: December 1, 2004
TIME: 1145
PHOTO BY: L. Range
PHOTO NUMBER: 6
ROLL NUMBER: 3
DIRECTION: South
COMMENTS: Photo taken of S107. S107 was collected from the area to be used as 119 th Street. S107 was collected from clean water at a depth of 1 ft. The depth of water at this location was approximately 1.5 ft deep.

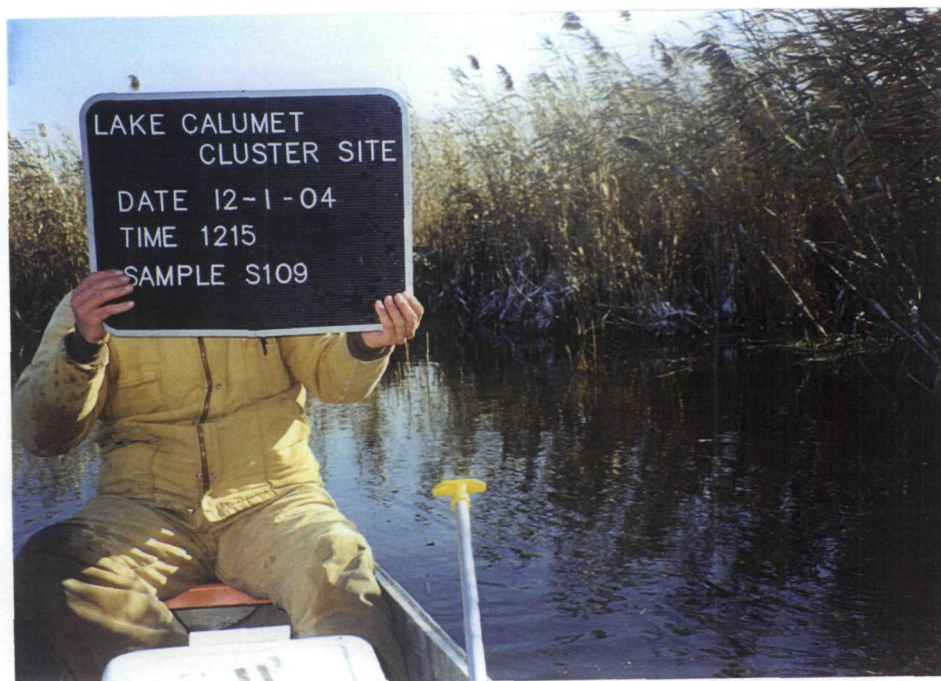
COMMENTS: Photo taken of S109. S109 was collected in the northeastern portion of the marsh for a potential background. S109 was collected from a depth of 1 ft. Depth of water at this location was approximately 1.5 ft.

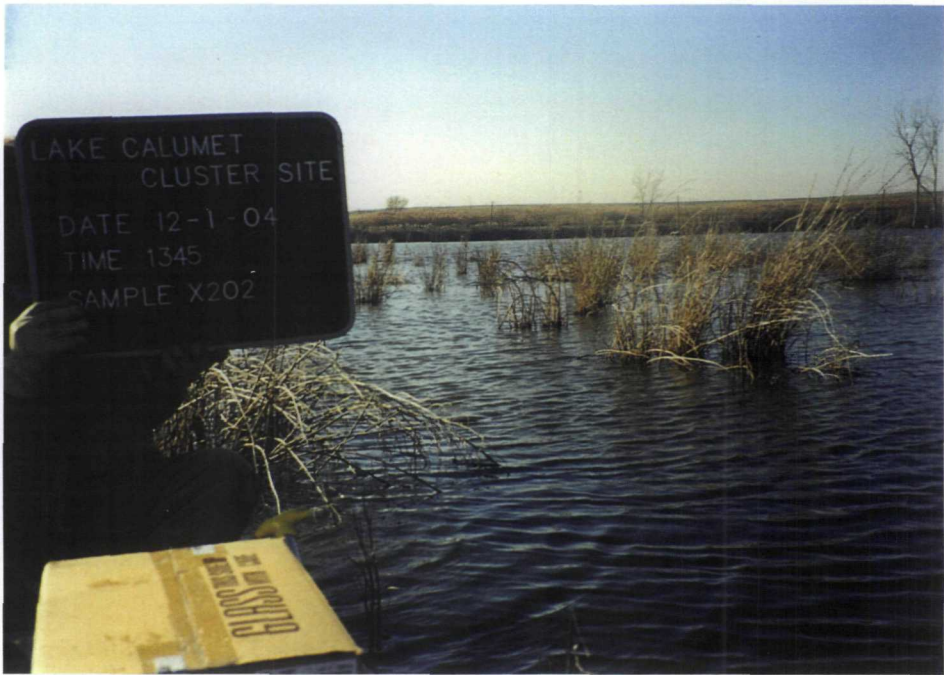
DATE: December 1, 2004
TIME: 1345
PHOTO BY: L. Range
PHOTO NUMBER: 9
ROLL NUMBER: 3
DIRECTION: West
COMMENTS: Photo taken of X202. Sediment sample was collected in the eastern portion of the far south lagoon. Sample consisted of a dark black fine silt. Slightly organic smell. Sample was collected from a depth of 6 to 12 inches. Depth of water in this location was approximately 1.5 ft in depth.

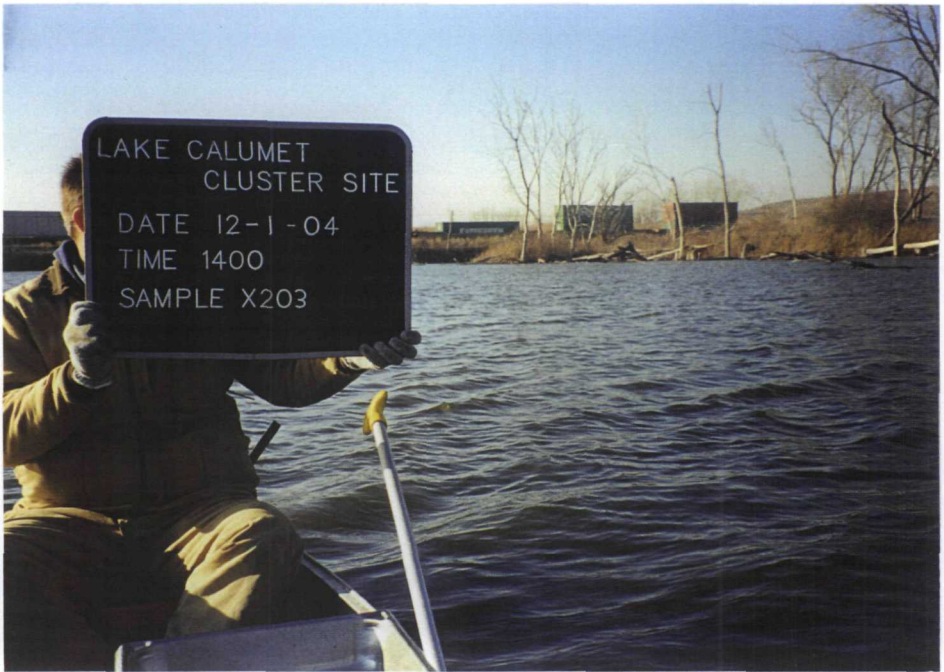
DATE: December 1, 2004
TIME: 1400
PHOTO BY: L. Range
PHOTO NUMBER: 10
ROLL NUMBER: 3
DIRECTION: West
COMMENTS: Photo taken of sample X203. This sample location was in the eastern portion of the southern part of the marsh. Sample consisted of a black soft silt with some organic debris. Sample was collected from a depth of 6 to 12 inches. Water in this area was found to be 1.5 ft deep.

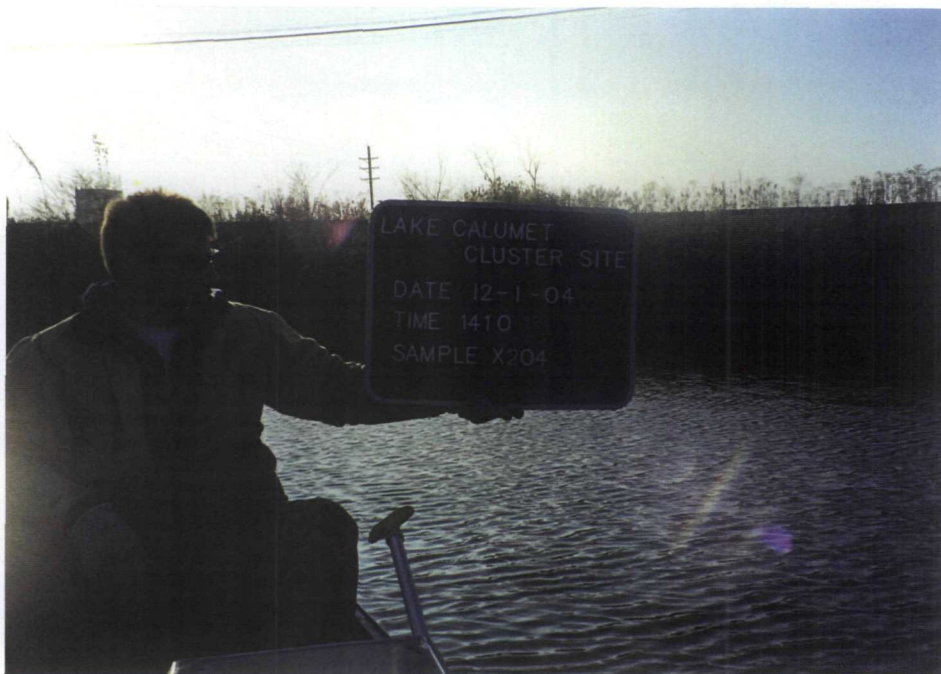
COMMENTS: Photo taken of X204. This sample location was at the southern end of the main channel that runs the length of the IRM. Sample consisted of a black silt which was very soft. Depth of water at this location was approximately 3.5 ft deep.

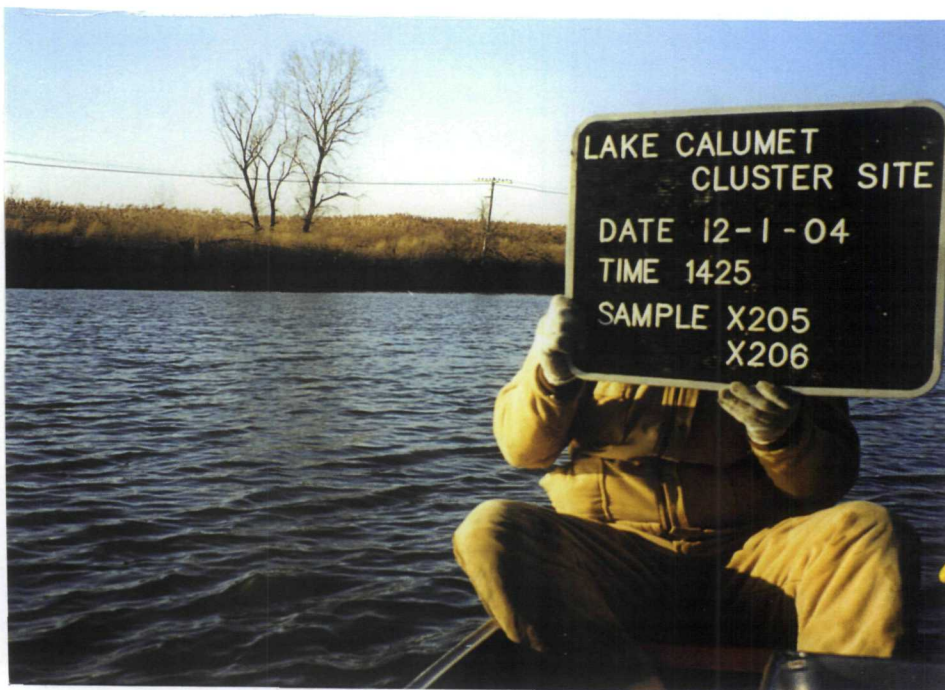
COMMENTS: Photo taken of X205 and X206 (duplicate). These samples were collected in the southern portion of the south lagoon area. These samples consisted of a black silt with some organic material. Water in this area is approximately 2.5 ft deep.

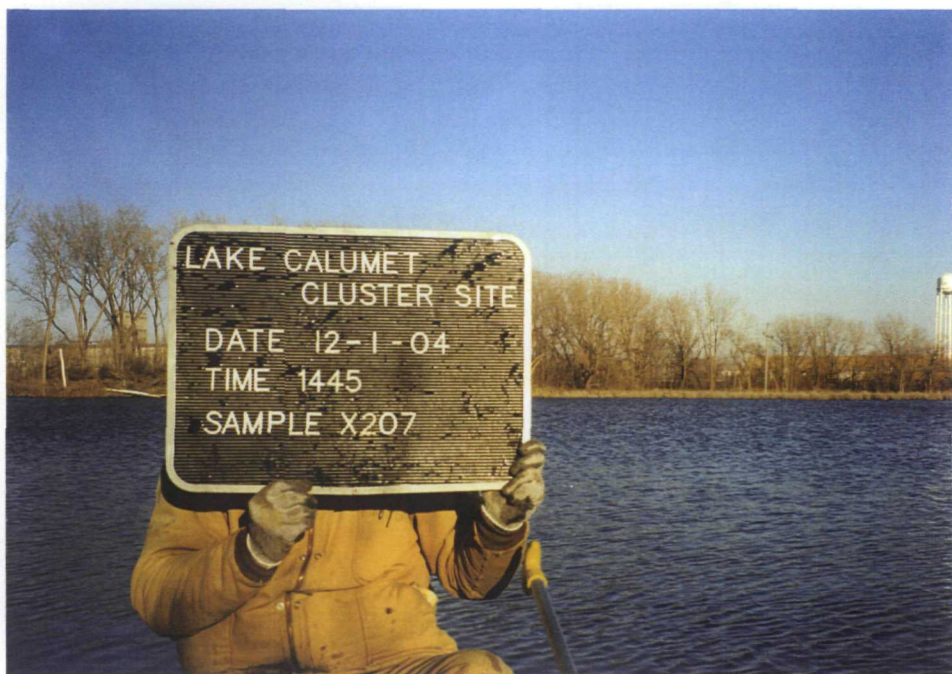
COMMENTS: Photo taken of samples X207. This sample was collected near the western edge of the marsh just east of the pond located in the southeastern portion of the Cluster Site. X207 consisted of black silts with some gravel, possibly railbed material. Sheen appeared on water surface after sample collection. Water from this location was approximately 2 ft deep.

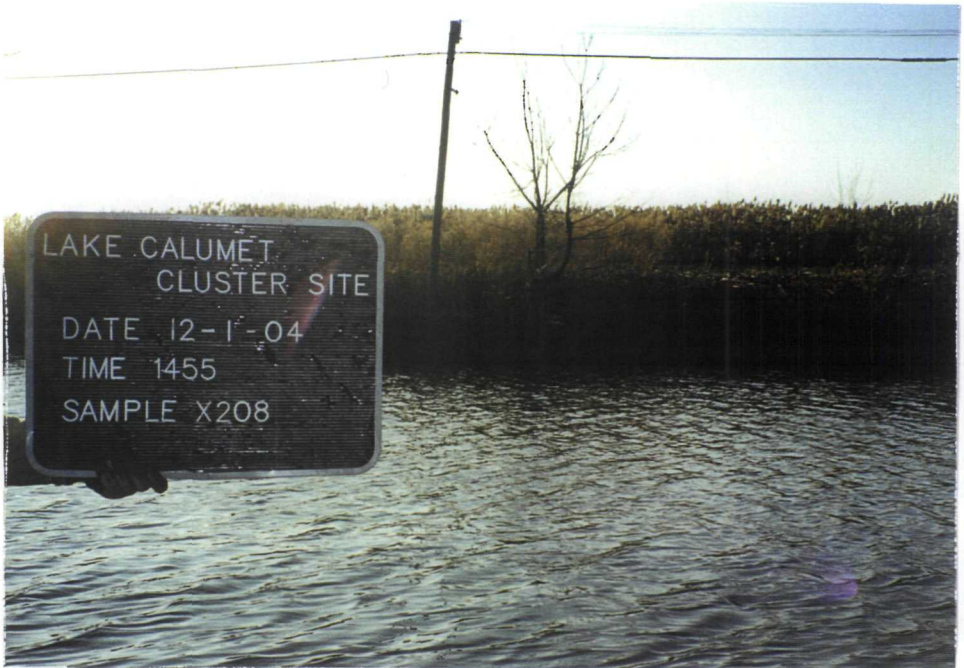
COMMENTS: Photo taken of X208. Sample was collected from a black silt which was slightly smelly. Sample was collected from a depth of 1 to 2 ft. Water in this area was found to be at a depth of 2.5 ft. Sample location was closer to the northern portion of the southern lagoon area.

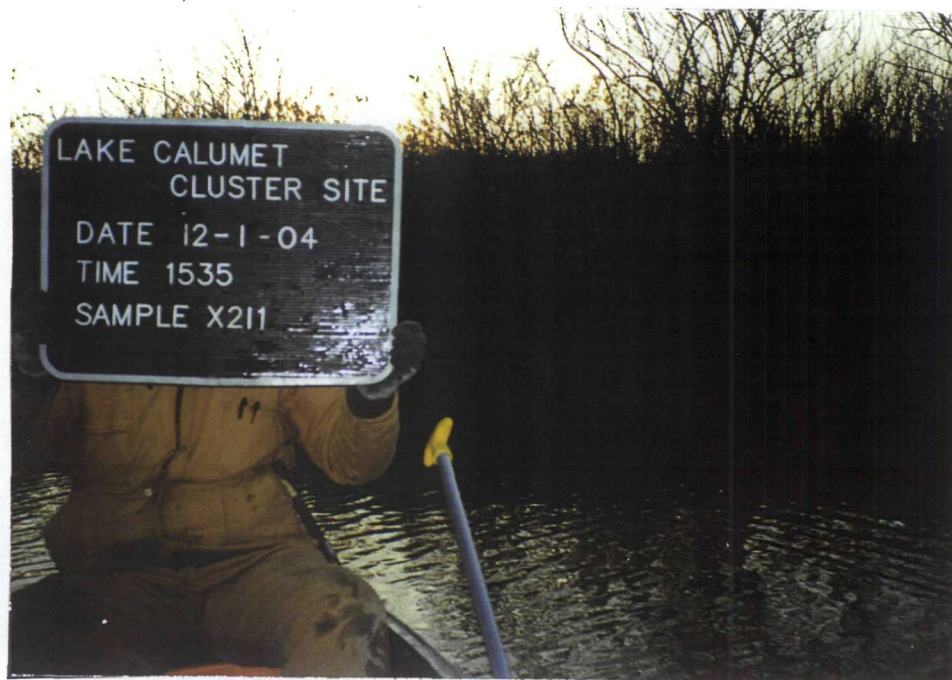
COMMENTS: Photo taken of sample X211. Sample was located near the middle of the middle lagoon of IRM. Sample consisted of very fine black silts. Depth of the water in this location was approximately 3 to 3.5 feet deep.
